LABORATORY BUILDING RENOVATIONS

Bender Labs at University Heights Campus

Owner: Renaissance Corporation
Contact: Mr. John Egan, (518) 514-0222
Budget: \$750,000 (MEP Only)
Completed: 2004

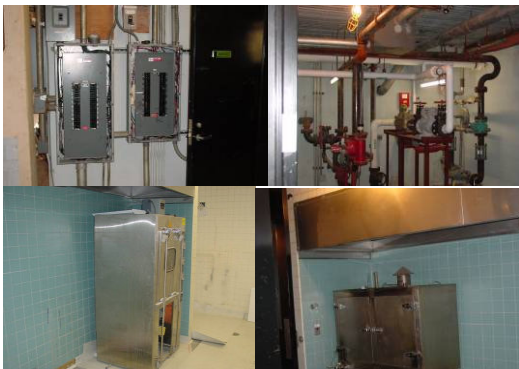
Above: The major building systems each needed significant redesign and renovation.
